Test Report

No. SZXEC2103062711

The following sample(s) was/were submitted and identified on behalf of the clients as : BRONZE

RoHS Directive (EU) 2015/863 amending Annex II to Directive 2011/65/EU

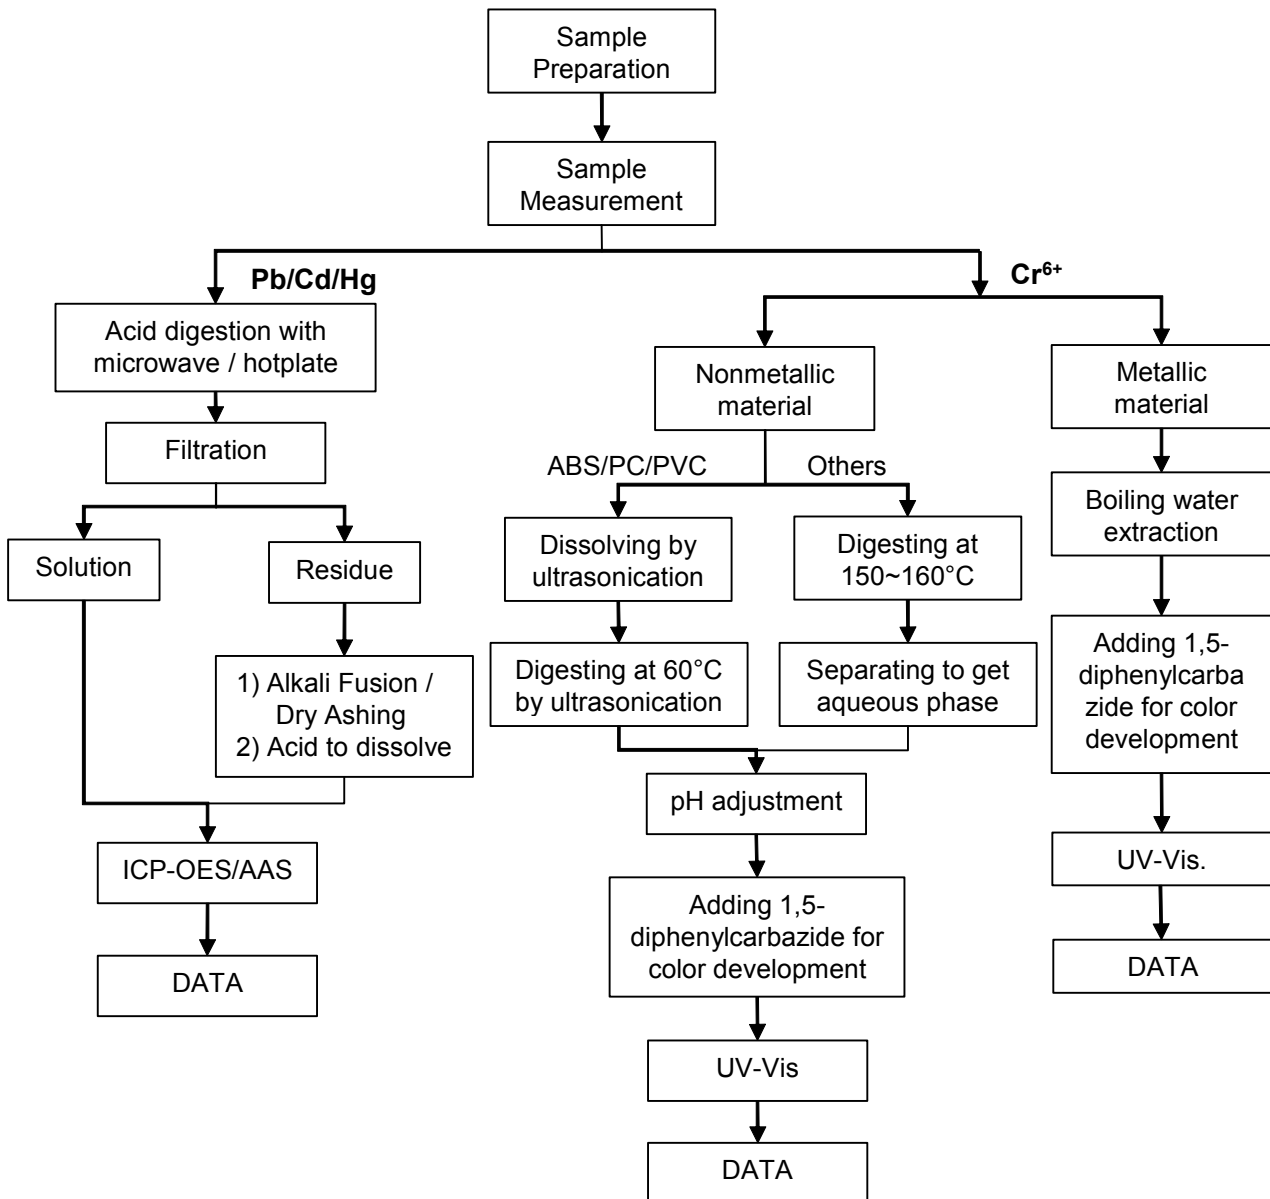
Pb/Cd/Hg/Cr⁶⁺ Testing Flow Chart

1) These samples were dissolved totally by pre-conditioning method according to below flow chart.
(Cr⁶⁺ test method excluded)

Test Method : With reference to IEC 62321-4:2013+AMD1:2017, IEC62321-5:2013, IEC 62321-7-1:2015, analyzed by ICP-OES and UV-Vis.

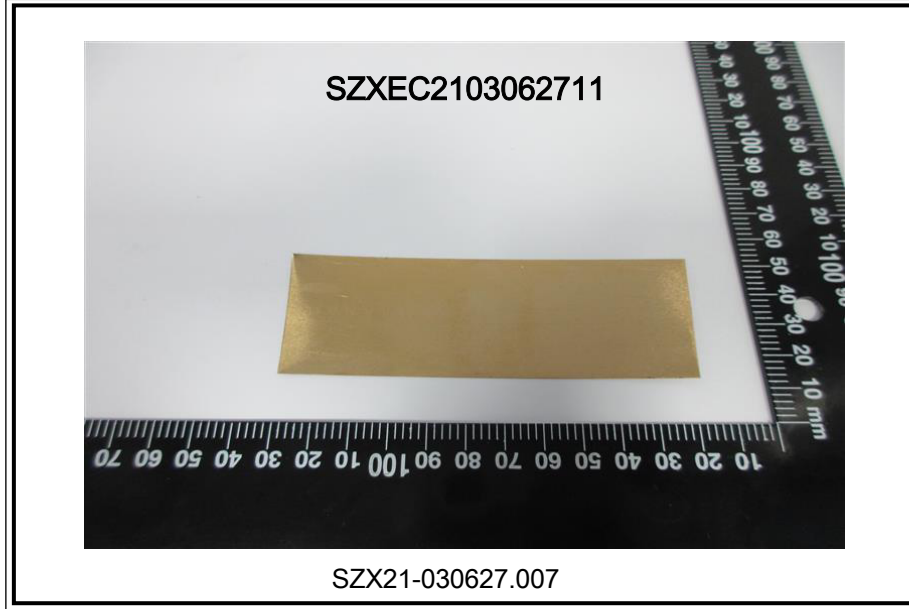
Sample photo:

Specimen No.	SGS Sample ID	Description
SN1	SZX21-030627.007	Copper-colored metal 7#
